Quality Assurance and Source Inspection

Contract #: 04-0120F4Cty: SF/ALA Rte: 80 PM: 13.2/13.9File #: 69.28**WELDING INSPECTION REPORT****Resident Engineer:** Pursell, Gary**Address:** 333 Burma Road**City:** Oakland, CA 94607**Report No:** WIR-012414**Date Inspected:** 02-Mar-2010**Project Name:** SAS Superstructure**OSM Arrival Time:** 645**Prime Contractor:** American Bridge/Fluor Enterprises, a JV**OSM Departure Time:** 1845**Contractor:** Zhenhua Port Machinery Company, Ltd (ZPMC), Changxing Island **Location:** Shanghai, China**CWI Name:** Liu Hua Jie, Geng Wei.**CWI Present:** Yes No**Inspected CWI report:** Yes No N/A**Rod Oven in Use:** Yes No N/A**Electrode to specification:** Yes No N/A**Weld Procedures Followed:** Yes No N/A**Qualified Welders:** Yes No N/A**Verified Joint Fit-up:** Yes No N/A**Approved Drawings:** Yes No N/A**Approved WPS:** Yes No N/A**Delayed / Cancelled:** Yes No N/A**Bridge No:** 34-0006**Component:** Orthotropic Box Girder(OBG)**Summary of Items Observed:**

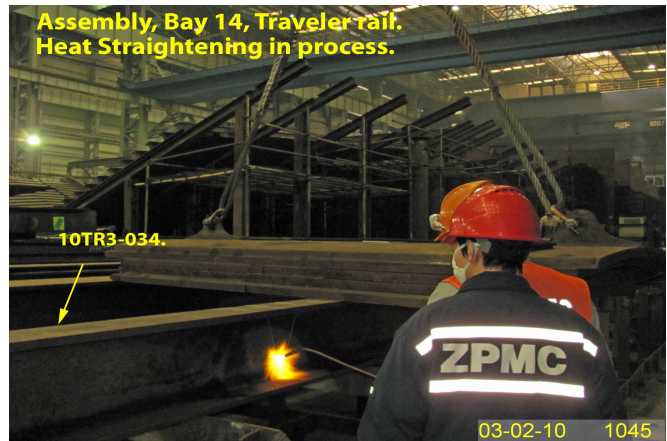
Assembly, Bay 14, Traveler rail.

During Random Visual in process Inspection, this QA inspector observed ZPMC personnel performing Heat Straightening on Traveler rail identified as 10TR3-034. The attached photographs provide additional detail.
